## Roof Example 1

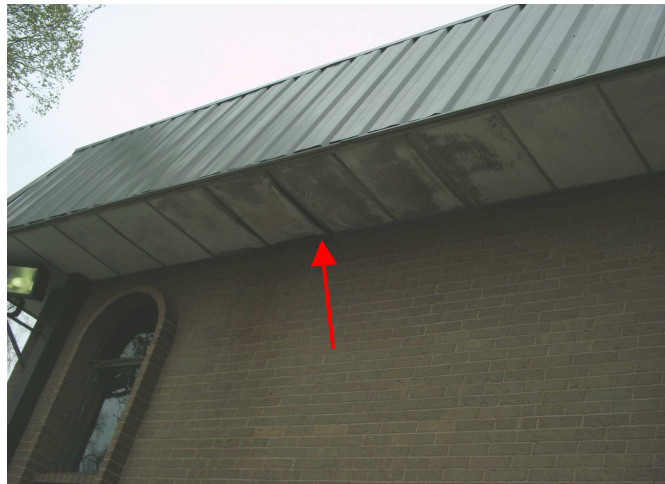
The following images show a roof area on a commercial building. Figure 1 shows obvious damage to the acoustic tiles used for the soffit. The source was a leaking gutter above the soffit. The gutter was supposedly repaired and the tiles were replaced. The repaired area does not appear to show any signs of leakage. However, in Figure 2, infrared imaging shows that gutter is probably still leaking and the same problem will begin to show itself after time. The infrared image was taken two days after rainfall and about 1 month after the repairs were made.

Figure 1. Roof eave before repair.

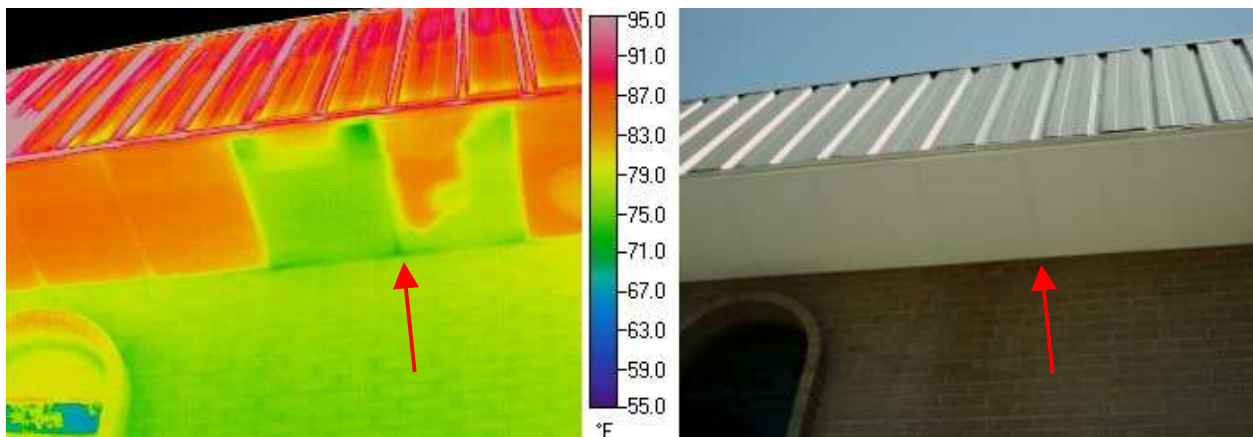
Figure 2. Infrared and visible images showing wet area after repairs.
